**Moisture damage evaluation of aggregate-bitumen bonds with the respect
of moisture absorption, tensile strength and failure surface**

Abstract: The moisture-induced deterioration of asphalt mixture is because of the loss of adhesion at the aggregate-bitumen interface and/or the loss of cohesion within the bitumen film. An experimental study was undertaken in this paper to characterise the effects of moisture on the direct tensile strength of aggregate-bitumen bonds. The aim of this paper was to evaluate the moisture sensitivity of aggregate-bitumen bonds in several different aspects, which included moisture absorption, tensile strength and failure surface examination. Moisture absorption and mineralogical compositions of aggregate were measured using gravimetric techniques and a Mineral Liberation Analyser (MLA), respectively, with the results being used to explain the moisture sensitivity of aggregate-bitumen bonds. Aggregate-bitumen bond strength was determined using a self-designed pull-off system with the capability of accurately controlling the bitumen film thickness. The photographs of the failure surfaces were quantitatively analysed using Image-J software. The results sh

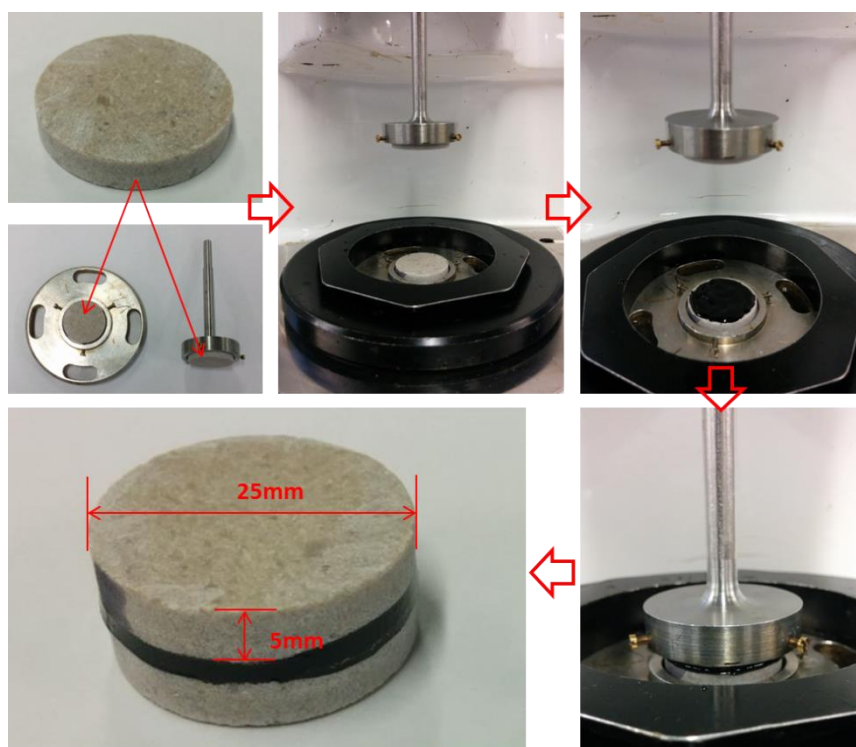
Figure 1. Aggregate-bitumen specimen preparation procedures

1
2 To prepare the aggregate-bitumen adhesion specimen, the cylindrical aggregate substrates
3 need to be prepared first. Samples of boulder sized aggregates were drilled using an
4 electrically operated water-cooled core drill to get aggregate cylinders with 25 mm diameter.
5 A trimming saw was then used to cut the aggregate cylinders into discs with 5 mm thickness.
6 The top and bottom surfaces of the discs were polished using a rotary polishing machine, to
7 remove all blemishes left by the sawing process and get parallel surfaces to ensure complete
8 adhesion between aggregate and bitumen. All discs were cleaned in an ultrasonic cleaning
9 machine for 15 minutes and dried in an oven at a temperature of 40°C for 24 hours. Two
10 aluminium holding plates were specially designed (diameter and thickness) and fabricated to
11 fit in a standard Bohlin Gemini DSR. With a view to precisely control the bitumen film

12 thickness, the two holding plates were designed to clamp the discs and then fixed into the
13 DSR machine. After establishing the zero gap and ensuring that the discs are parallel, a small
14 amount of hot bitumen was placed on the lower aggregate surface and then pressed with the
15 upper aggregate disc to achieve the required bitumen film thickness of 20 μm , with a gap
16 resolution of 1 μm . The sample was removed from the DSR after about 15 minutes of cooling
17 and then the excess bitumen removed by means of a heated pallet knife. Figure 1 shows the
18 whole procedure of the sample preparation.

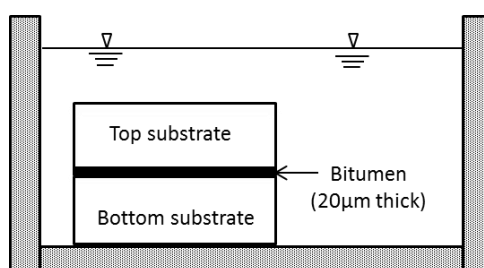
Figure 2. Specimen of aggregate-bitumen adhesion submerged into water

1 diagram of the moisture conditioning is shown in Figure 2. During the moisture conditioning,
2 moisture could reach the aggregate-bitumen interface in three different ways: through the top
3 and bottom aggregate, through the edge of aggregate-bitumen interface and through the
4 bitumen film.

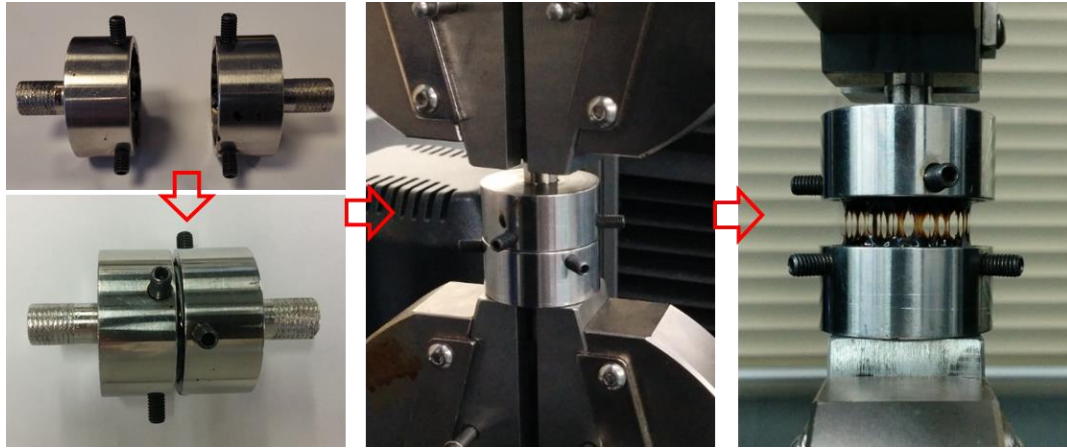
Figure 3. Procedures for pull-off test

7
8 The aggregate-bitumen interfacial bond strength in the dry condition and after periods of
9 moisture conditioning (24 hours and 168 hours) were determined by using a pull-off tensile
10 test with detailed procedures shown in Figure 3. Before the pull-off test, the specimen was
11 first fixed by two direct tension fixtures with three screws on each. These two fixtures
12 combined with the aggregate-bitumen specimen were then mounted on the UTM. An
13 extension speed of 10 mm/min and a temperature of 20°C were applied to break the interface.
14 However, depending on the equipment limitations, any available loading rate can be used.
15 During the test, the pull force as a function of elongation was recorded and the failure
16 surfaces of each broken sample were photographed with a digital camera to characterise the
17 loci of failure as either adhesive or cohesive. At least four repeat tests were made for each

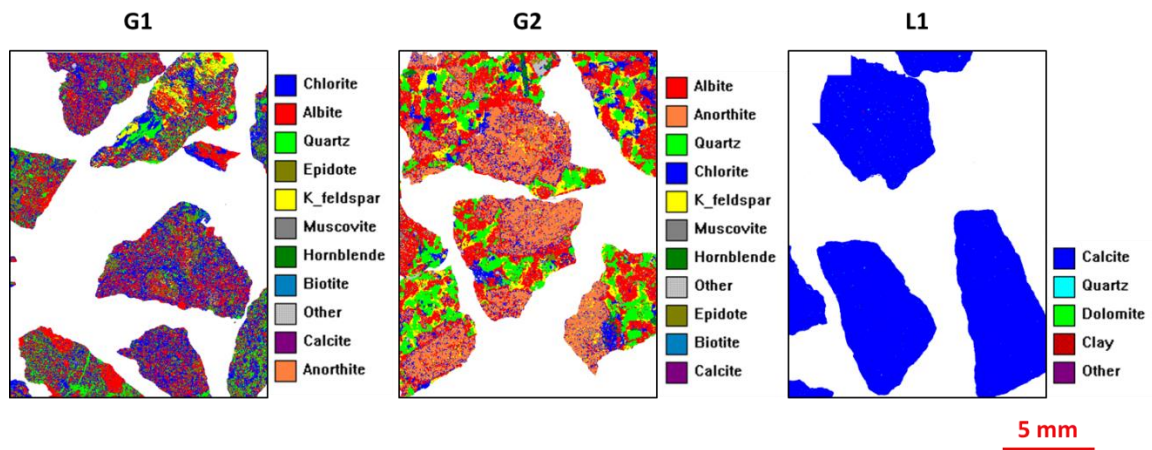
Figure 4. Mineral distribution of the three aggregates

Figure 4 shows the mineralogical distribution on aggregate surfaces obtained from the MLA with the mineralogical composition shown in Table 3. As shown in Figure 4, the mineral distribution of G1 and G2 is much more complex than that of L1. The two granite aggregates G1 and G2 were made up of a large number of different mineral phases, while there are very few mineral phases in limestone L1. As shown in Table 3, chlorite and albite are the foremost minerals in G1 with quantities of 31.53% and 27.13% by weight, followed by quartz, epidote and K-feldspar, which account for 19.11%, 11.11% and 4.82%, respectively. Albite and anorthite are the predominant minerals in G2, which account for 32.73% and 18.54% by weight, but quartz and chlorite also have significant quantities. In terms of limestone L1, calcite is the dominant phase with 96.98% by weight.

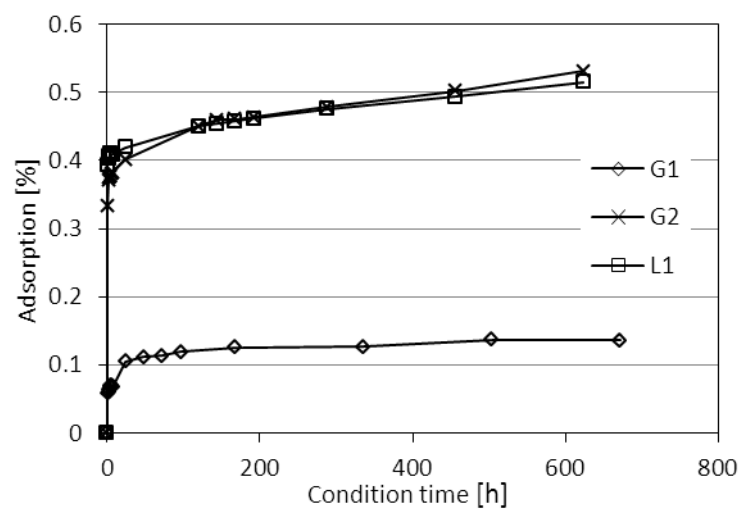
Figure 5. Moisture uptake of the three aggregates used in this research

Water absorption data were obtained from these three aggregates used for substrates in this research. In order to know how much water was diffused into the aggregate during the immersion time, a water absorption test was performed and the results are shown in Figure 5. As shown in this figure, more than 80% of the moisture was absorbed during the first 24 hours of conditioning. After that, the water uptake of L1 and G2 experienced a slow growth and finally reached slightly over 0.5% although the water absorption of L1 and G2 still seems to be increasing and has probably not reached equilibrium. G1 showed the lowest water uptake with the result being only 0.13% after 600 hours conditioning. The obvious difference

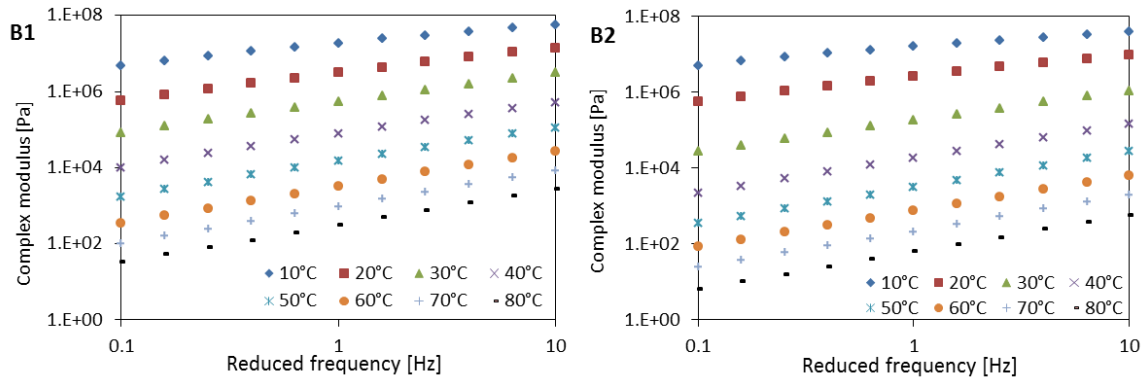
Figure 6. Complex modulus results for the two binders used in this research

It has been suggested that bitumen is the only agent that binds aggregates together in asphalt mixtures and its properties directly affect the performance of asphalt pavements. So, rheological measurements were conducted at eight temperatures from 10°C to 80°C in the frequency range of 0.1-10 Hz. Figure 6 shows the shear complex modulus of the two bitumens used in this research, and the values increase with increased frequency. It was found that bitumen B1 and B2 exhibit similar complex modulus values at 10°C. As the temperature increases above 20°C, the B1 bitumen shows higher complex modulus results in comparison with the B2 bitumen. Bitumen showing higher complex modulus is likely to form a stiffer bond to resist the direct tensile forces. Based on the penetration classification of the binders B1 (40/60) and B2 (70/100), the results are as expected and reliable.

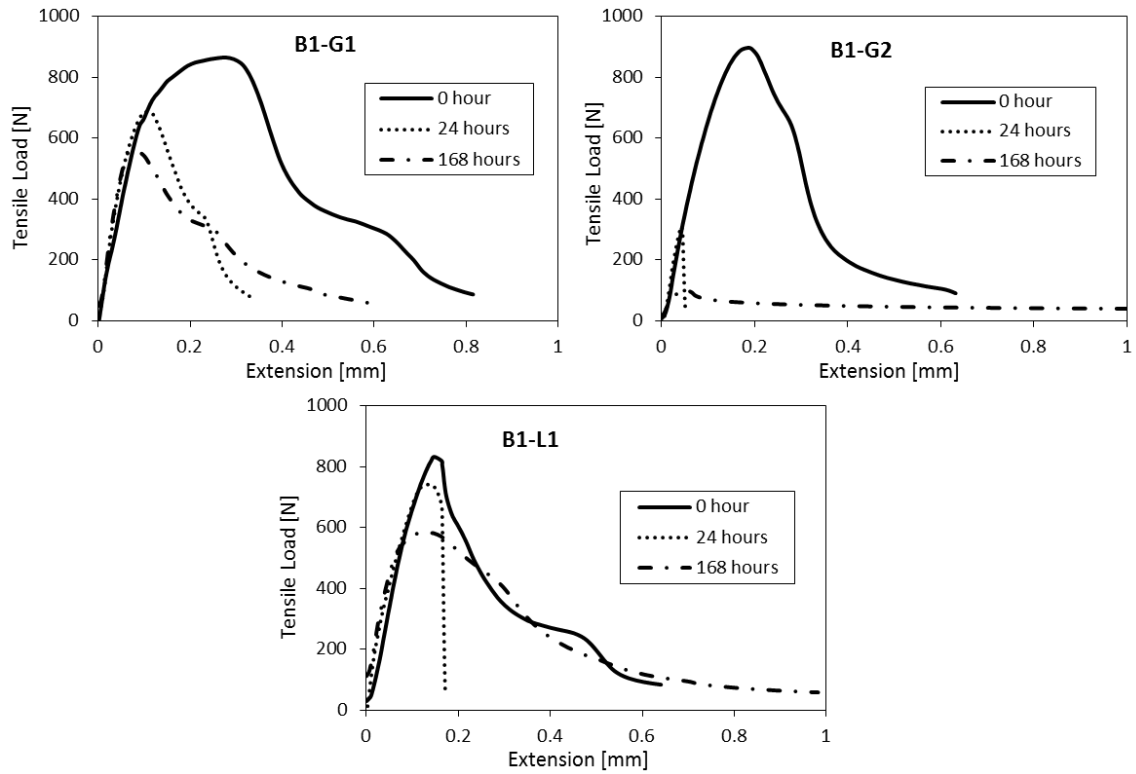
Figure 7. Development of stress-strain behaviour of aggregate-bitumen combined samples with respect to moisture conditioning time. Samples were conditioned in water at 20°C; loading rate was 10mm/min.

To simulate the effect of moisture on the stress-strain properties of the aggregate-bitumen bonds, the pull-off tests were performed by continuously recording the tensile load and the displacement of cross-head. Figure 7 shows the development of the stress-strain behaviour with the respect to the moisture conditioning time. The tensile loads of all specimens experienced a decrease after moisture conditioning with the B1-G2 combination obtaining the biggest decline. The stress-strain curve of B1-L1 and B1-G2 after 24 hours moisture conditioning experienced a sharp decline once the peak load was reached, showing totally different behaviour from other specimens. This could be because the short-term moisture conditioning makes the bitumen harder so that it has no chance to release during the loading process. Due to the lower moisture absorption of G1 aggregate as shown in Figure 5, it is difficult for moisture to reach the aggregate-bitumen interface in such a short period of time so that the sharp drop of the tensile load does not appear in the B1-G1 combination. After 168 hours of conditioning, the peak load for B1-G2 decreased from about 900 N to less than 100 N demonstrating its poor resistance to moisture attack. In contrast, B1-L1 and B1-G1 experienced much less decrease of peak loads meaning better moisture resistance.

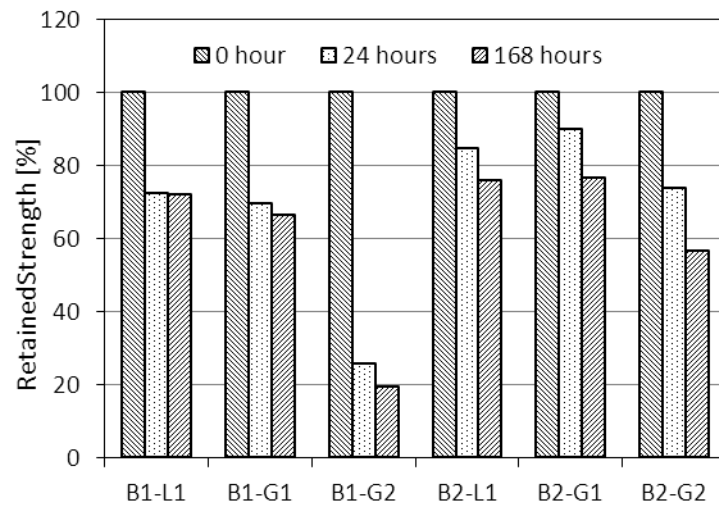
Figure 8. Retained tensile strength of different aggregate-bitumen combinations with the passage of conditioning time

Retained strength, the ratio of bond strength after a given level of moisture conditioning to the dry bond strength, is considered to be a common parameter to measure the moisture sensitivity of asphalt mixtures. High retained tensile strength demonstrating better moisture resistance of the specimen. Figure 8 shows the effect of conditioning time on retained tensile strength of different aggregate-bitumen bonds. By using the pull-off test results, it is possible to identify ‘good’ and ‘bad’ mixtures. It can be seen that samples prepared with L1 and G1 show good moisture resistance with over 70% tensile strength retained after 168 hours

conditioning. However, samples prepared with G2 are more sensitive to moisture attack as the tensile strength decreased by over 80% and 40% for B1 and B2 bitumen, respectively. The aggregates L1 and G2 have similar moisture absorption, meaning similar time will be taken to transport moisture to aggregate-bitumen interface, but they show a significant difference in retained strength. This is because the bonds formed between bitumen and G2 are quickly degraded once in contact with moisture due to the large amount of albite and quartz. However, calcite, being the dominant mineral in L1, can form water insoluble bonds with bitumen that retain better moisture resistance. In terms of G1, due to its lower water absorption, it will take a much longer time for water to reach the aggregate-bitumen interface. On this basis, there is limited chance for water to attack the bonds even though G1 contains several moisture sensitive minerals. The difference in retained strengths between G1 and G2 could be attributed to higher moisture absorption of the latter. This later result combined with the L1 results previously discussed leads one to conclude that for susceptible aggregates, the amount of moisture absorption is a significant factor. In summary, the moisture-induced damage of the aggregate-bitumen bond is not only controlled by the mineralogical composition, but also the moisture absorption of aggregate should be considered.

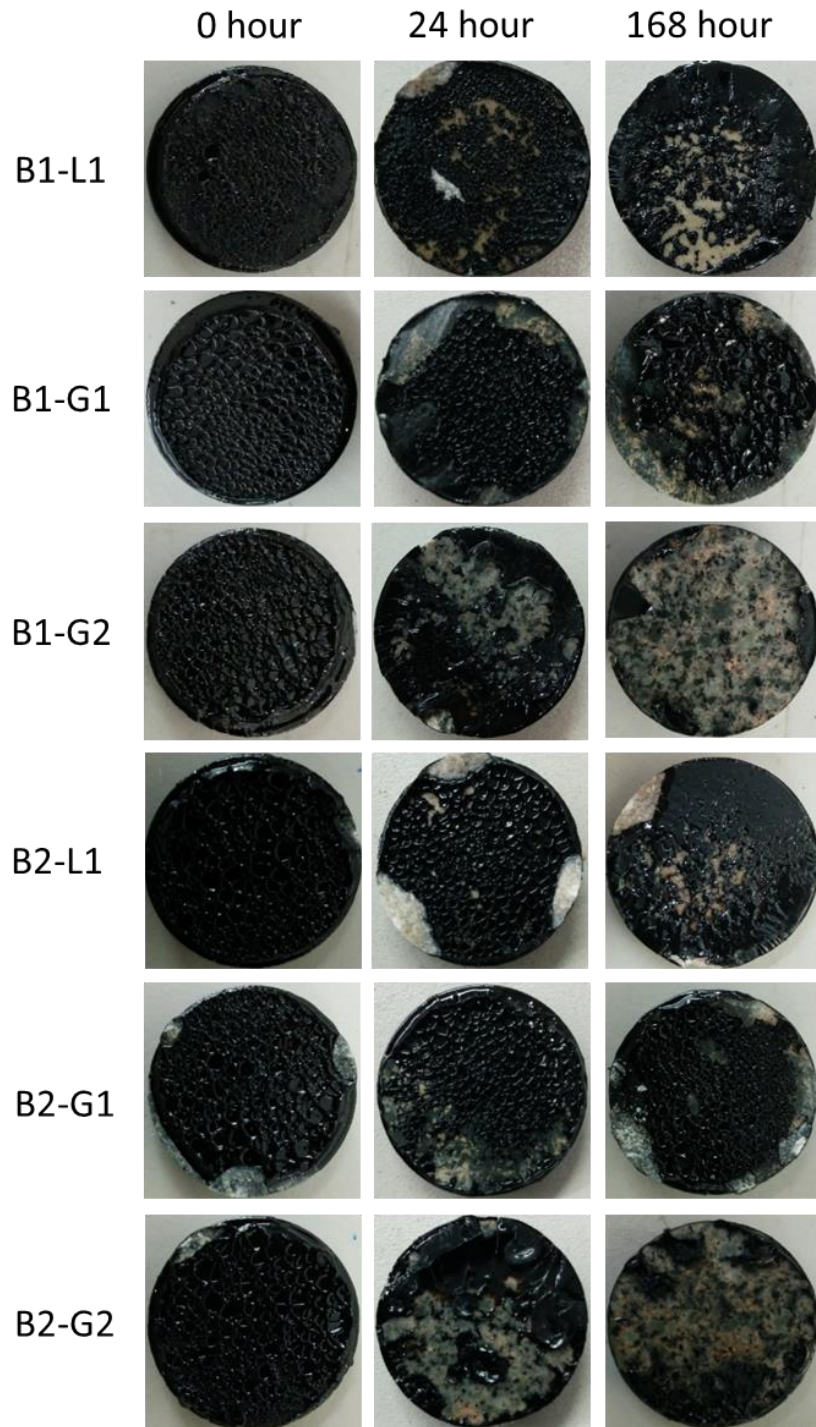
Figure 9. Failure surface photographs of aggregate-bitumen bonds before and after moisture conditioning. The effect of bitumen type is minimal compared with the effect of aggregate type

Figure 9 shows the fracture surface photographs of the aggregate-bitumen specimens, taken immediately after the pull-off tensile test. The failure surfaces could be visually defined into

three types which are cohesive, adhesive and adhesive-cohesive mix. From this figure it can be seen that all specimens show cohesive failure in the dry condition. After moisture conditioning, the failure tends to transform from cohesive to adhesive-cohesive mix and even adhesive failure. It can be seen that specimens prepared with L1 aggregate retained the most cohesive failure, followed by G1, while specimens with G2 showed the least cohesive failure.

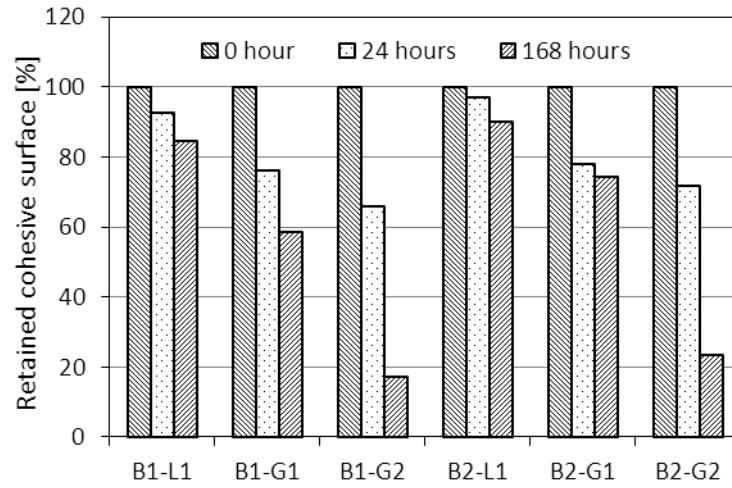
Figure 10. Retained cohesive surface percentage of different aggregate-bitumen combinations with the passage of conditioning time

Based on the photographs obtained, the damage proportions of all specimens were analysed using Image-J software. The percentage of the cohesive section of each specimen was calculated by identifying the grayscale levels, with results shown in Figure 10. The results shown in Figure 10 are important for two main reasons. Firstly, it allows a quantitative comparison of different specimens to identify the best aggregate-bitumen combination. Secondly, the results could be used to correlate with other parameters such as water absorption and retained tensile strength so as to confirm the identification. From this figure it can be seen that the retained cohesive failure was aggregate type dependent. Specimens prepared with L1 aggregate show the highest retained cohesive failure while G2 show the lowest value. In terms of the same aggregate, the influence of bitumen on the failure surface was not significant.

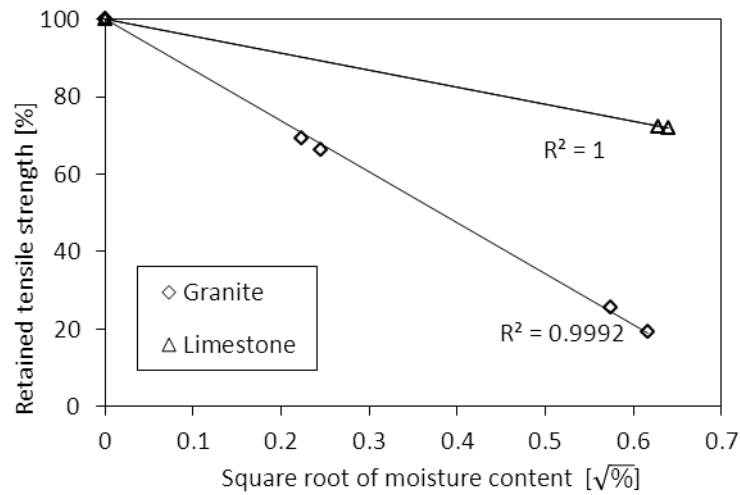
Figure 11. Correlation between retained tensile strength and square root of moisture uptake: specimens prepared with bitumen B1

aggregates may absorb different amounts of water to attack the aggregate-bitumen interface. Just using conditioning time may not be adequate to evaluate the sensitivity of aggregate-bitumen bonds to moisture. Based on previous research (Apeagyei et al., 2015, Kringos, Scarpas & De Bondt, 2008), the relationship between retained strength and moisture uptake has been considered more realistic to characterise the moisture damage. Figure 11 shows the retained tensile strength of the specimens prepared with B1 bitumen versus the square root of moisture absorption. From this figure it can be seen that the retained tensile strength and square root of moisture content show a negative relationship. This demonstrated that by using the same type of aggregate, moisture uptake dominated the degradation of the aggregate-bitumen bonds. The bigger slope of granite than limestone suggesting it is more sensitive to moisture attack. In short, the deterioration of aggregate-bitumen bonds correlate well with the moisture uptake.

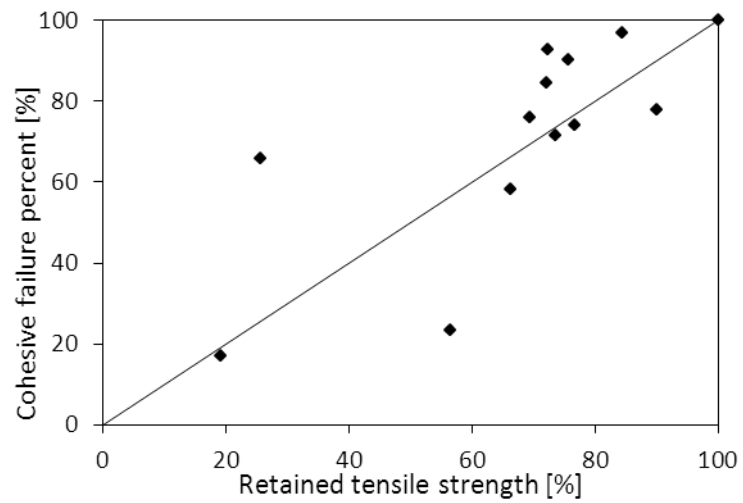
Figure 12. Correlation between retained tensile strength and cohesive failure percentage: all specimens (B1-L1, B1-G1, B1-G2, B2-L1, B2-G1 and B2-G2) and conditioning time (0 hour, 24 hours and 168 hours) included.

The relationship between retained tensile strength and cohesive failure percentage of all specimens is shown in Figure 12. It can be seen that all results are located near the equality line with a higher percentage of cohesive surface achieving higher retained tensile strength. The results suggested that the deterioration of tensile strength is due to the transformation from cohesive failure to adhesive failure. So, the cohesive failure percentage could reflect the deterioration of the aggregate-bitumen bond the same way as retained tensile strength.
